## **Shore Status, Evolution, and Storm Vulnerability Assessments for George Washington Birthplace National Monument**

## **Shore Status, Evolution, and Storm Vulnerability Assessments**

## Technical Report

May 2009

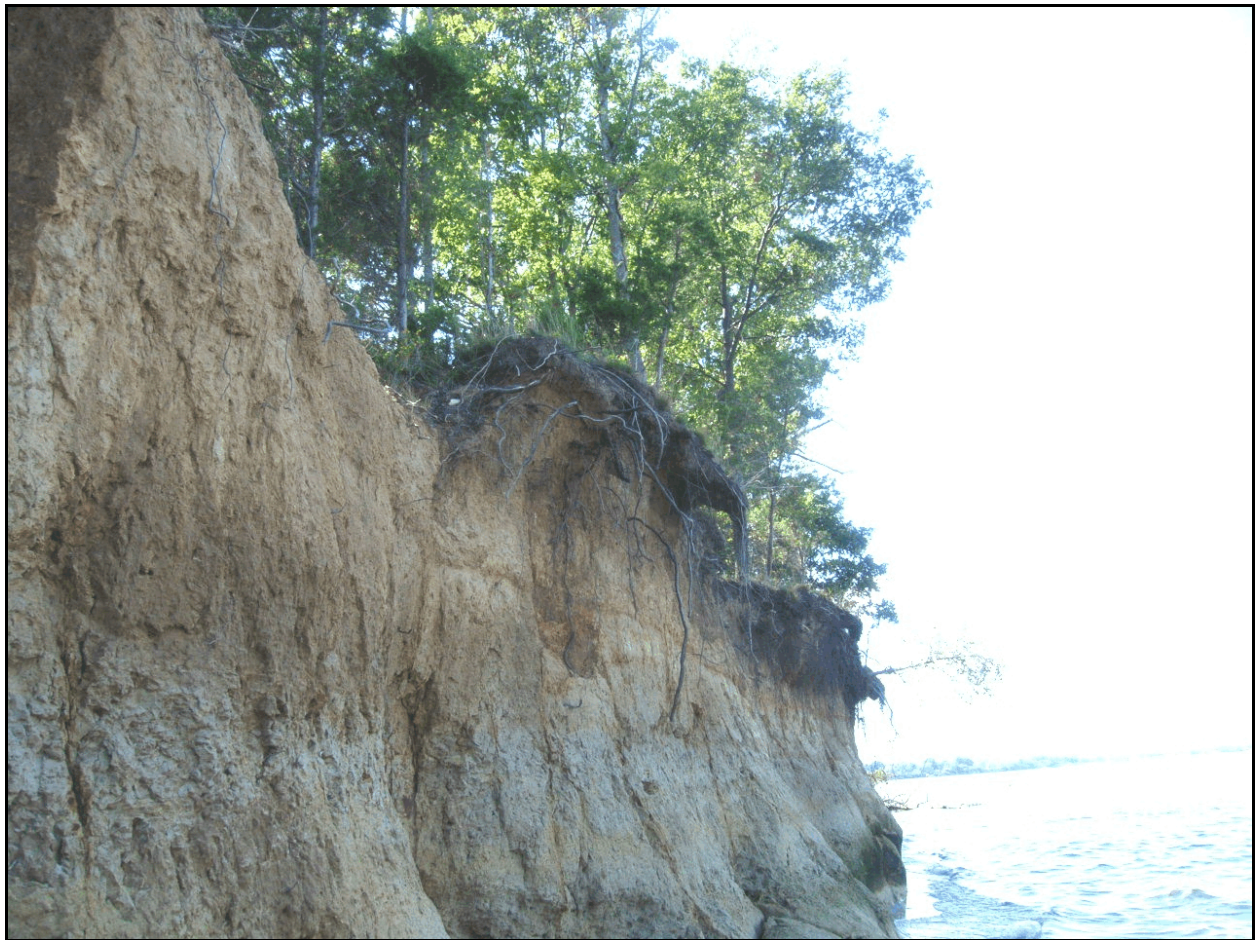
Eroding high banks along the Potomac River at the George Washington Birthplace National Monument on 18 September 2008.  
Photography by: Shoreline Studies Program, Virginia Institute of Marine Science

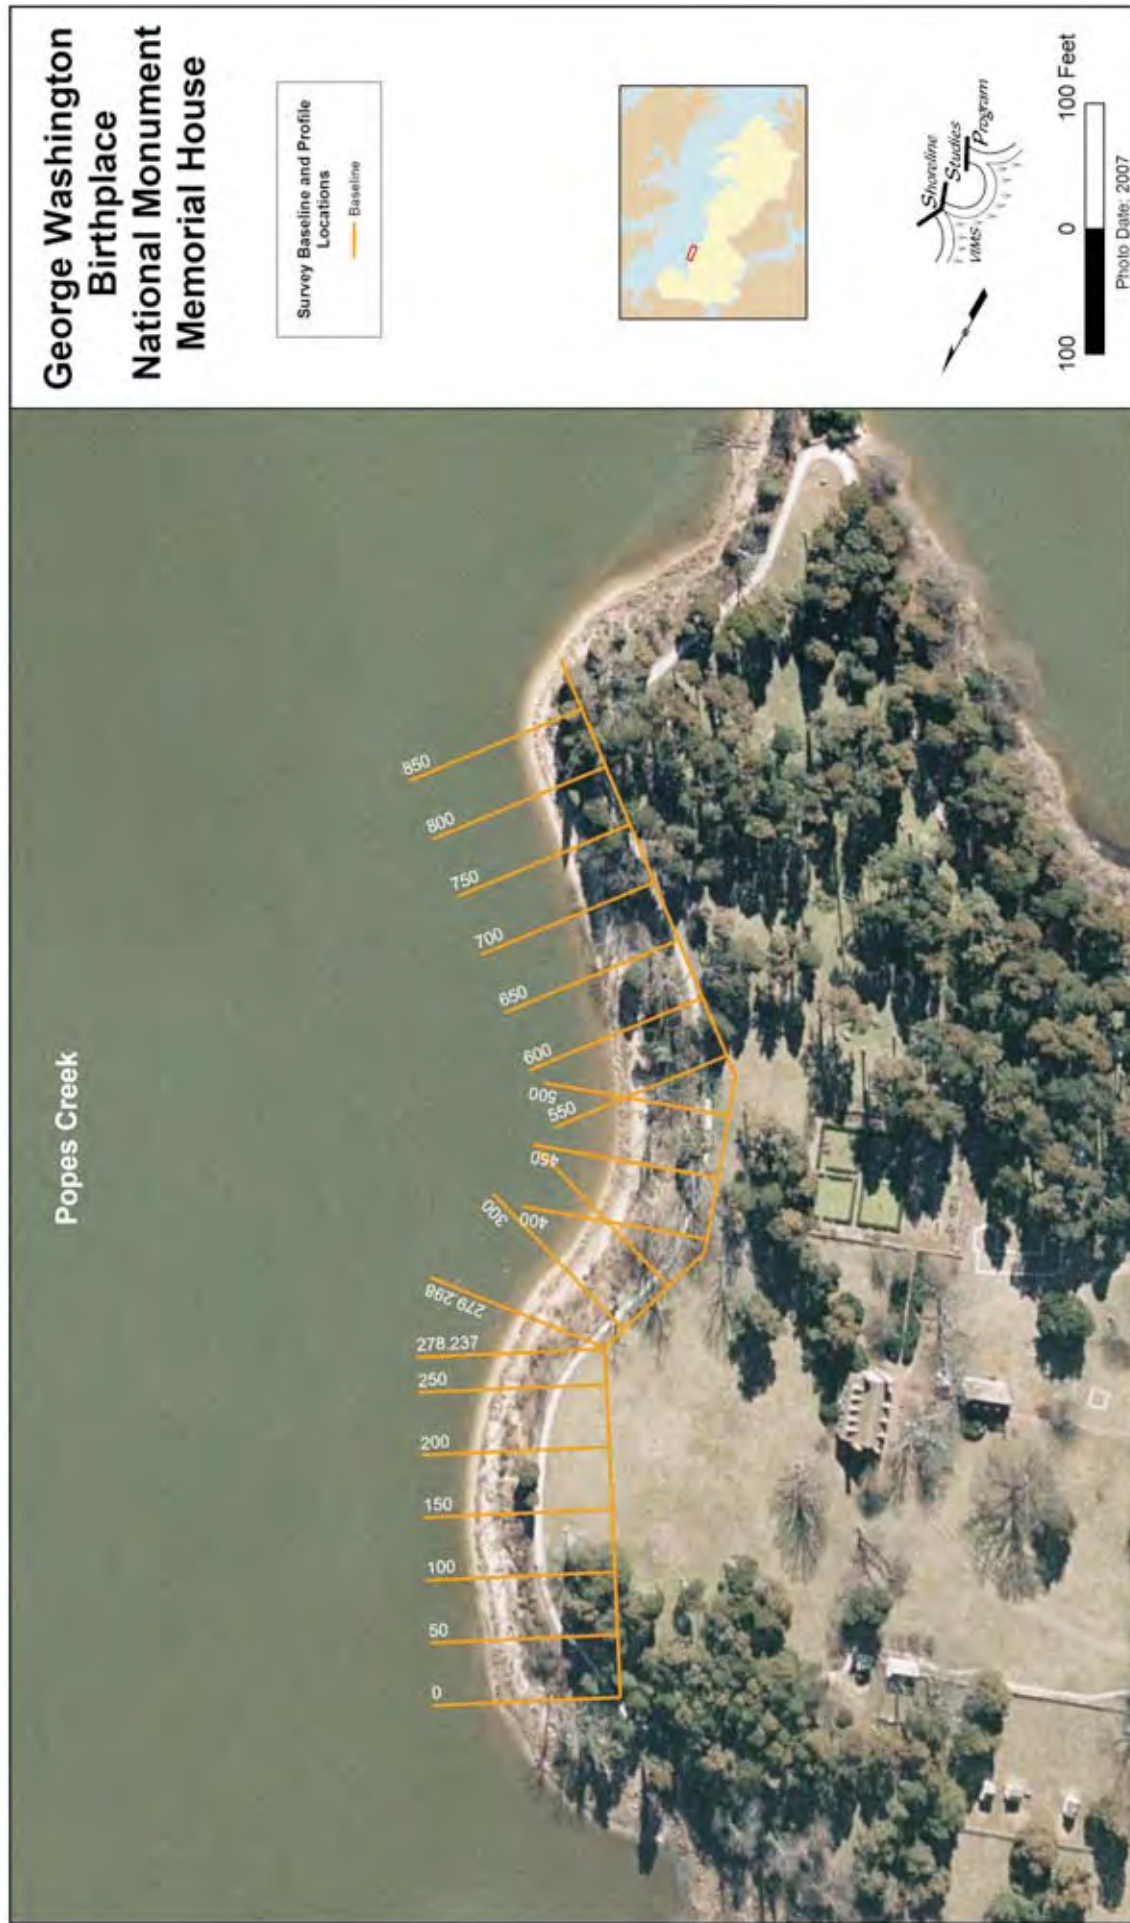
Figure 5. Location of profile cross-sections along Popes Creek.

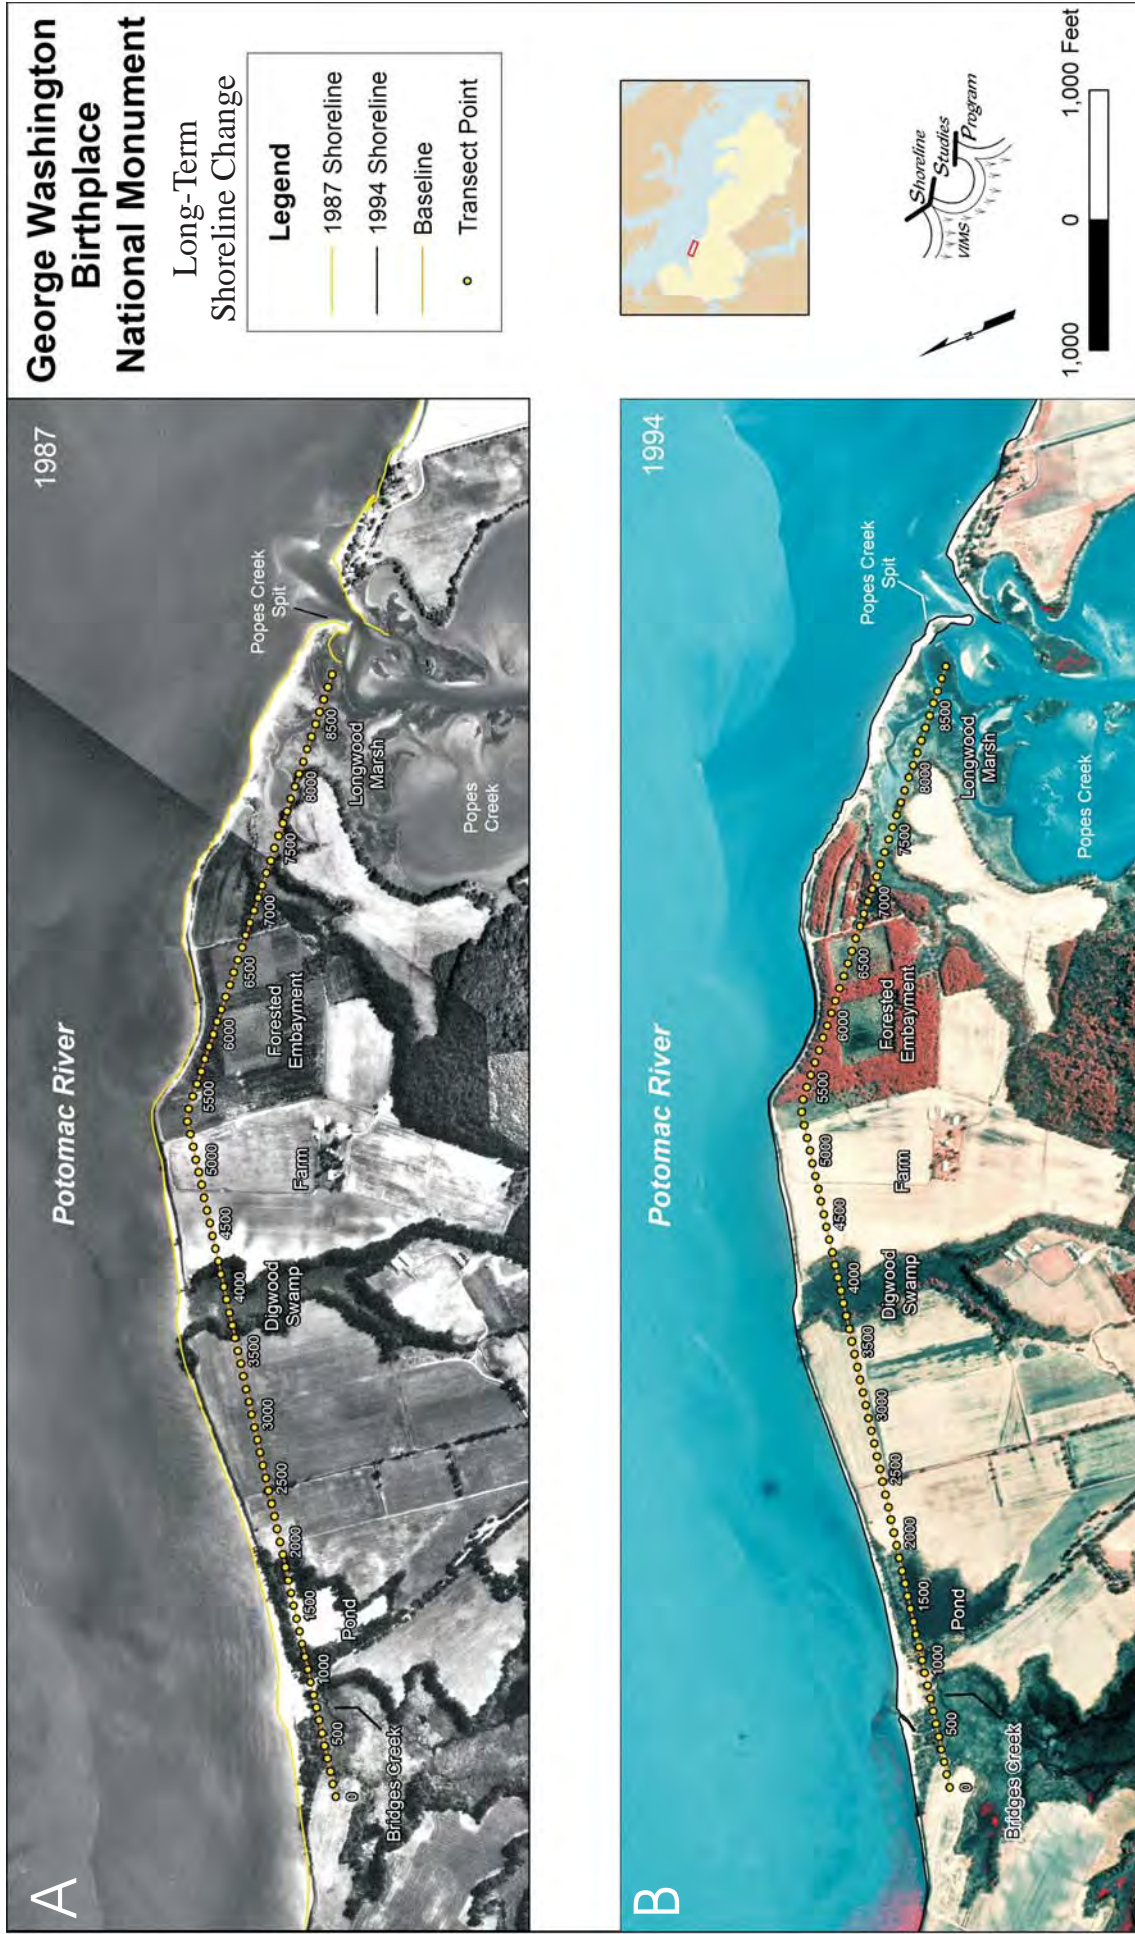
Figure 14. A) 1987 and B) 1994 ortho-rectified historic aerial photos with digitized shoreline and the baseline used for rate of change analysis.

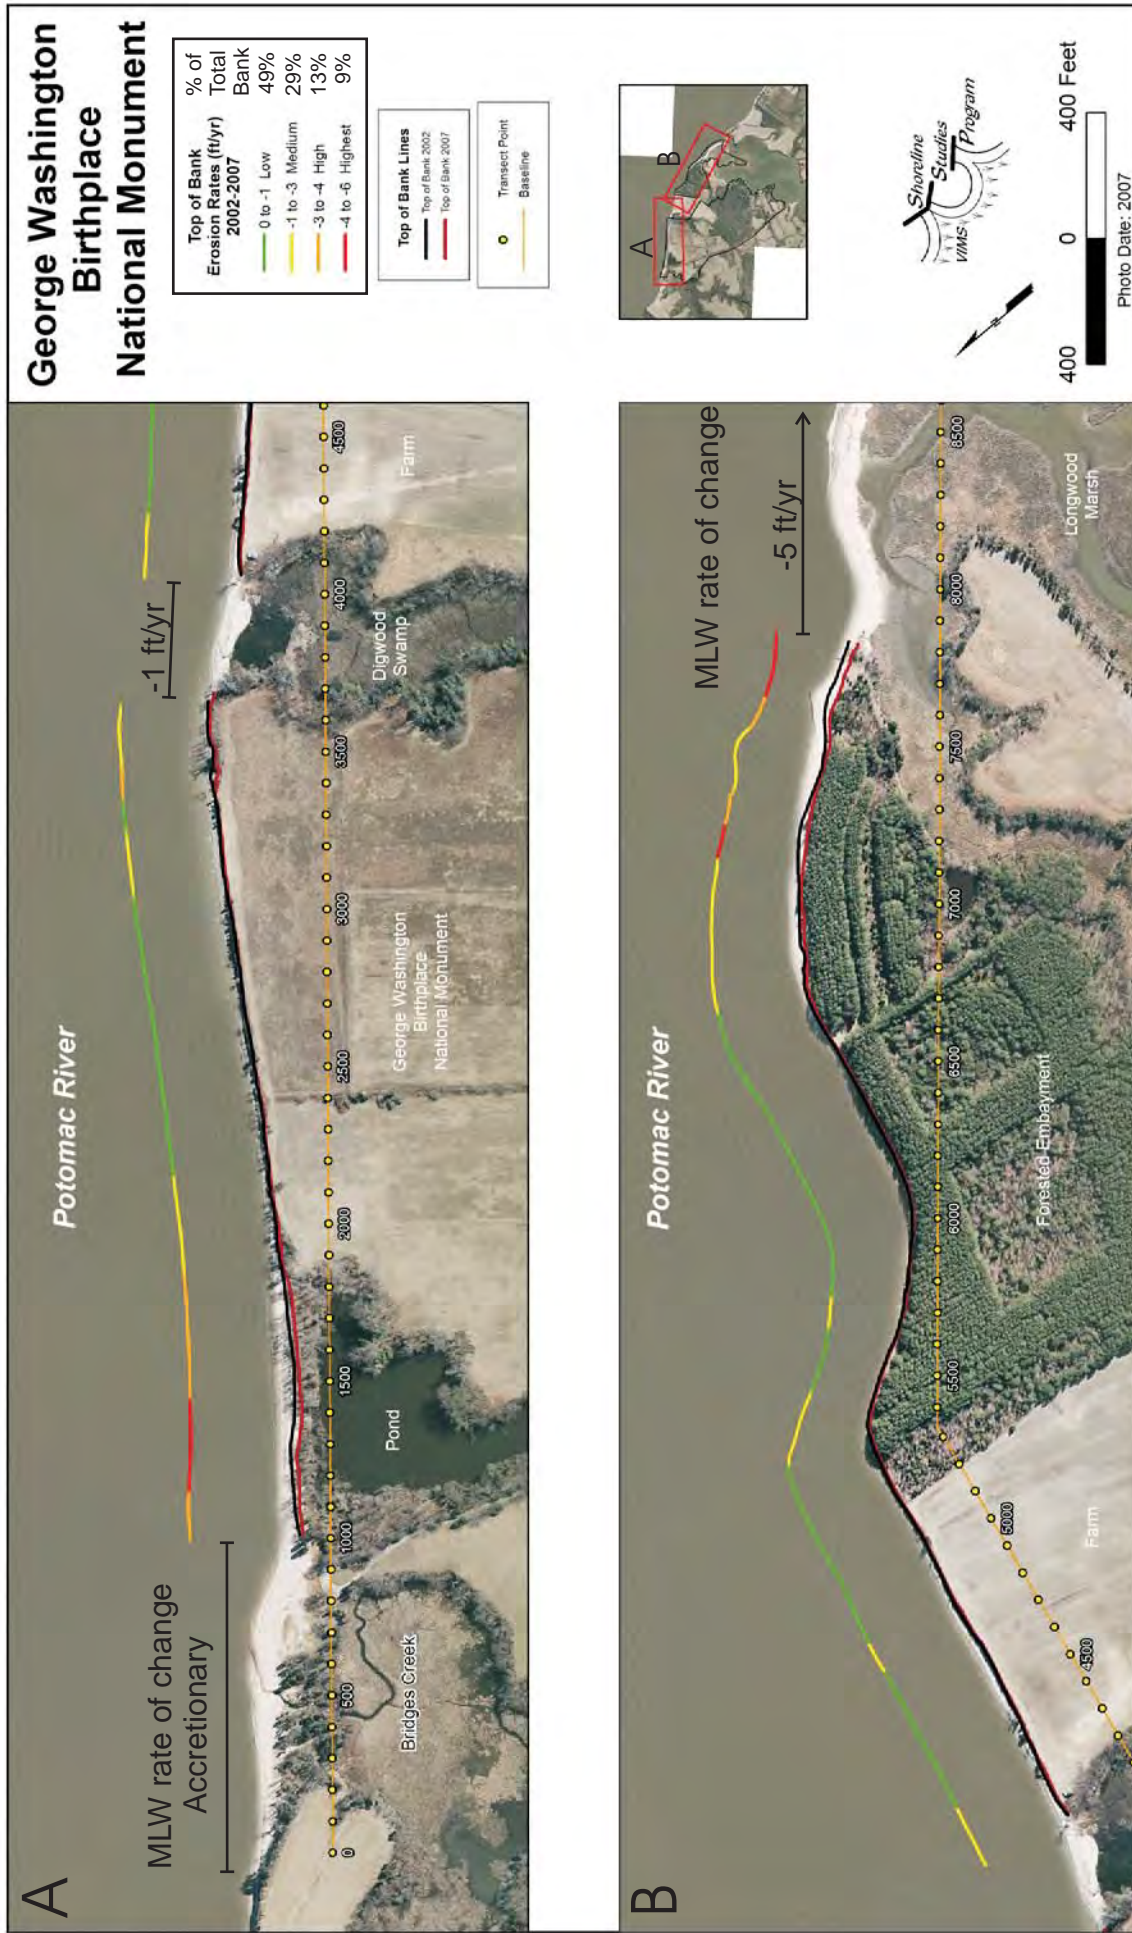
Figure 18. Top of bank digitized from 2002 and 2007 ortho-rectified aerial photos showing the cumulative impact to the shoreline of Hurricane Isabel and Tropical Storm Ernesto. Also shown on the images are the calculated rate of change averaged along the shore at MLW for areas that do not have banks. See Figure 17 for detailed rates in these areas.

The rate of bank change from 2002 and 2007 ([Figure 18](#)) reflects the storm impact of Hurricane Isabel, Tropical Storm Ernesto, and the northeast storms of October 6 and November 22, 2006. While an individual storm may have a peak 50-year return frequency, the hydrodynamics or wave power actually go through the 10 and 25 year events on each side of the peak for each storm. The top of the bank showed the highest rates of loss in front of the Pond and along the shore with the deteriorated bulkhead. These sections of the shore have lower banks that likely were not overtopped by storm surge, but the waves were breaking on them. The low bank in front of the Pond has a narrow beach, but it apparently did little to attenuate wave action from these storms. Bank losses on either side of Digwood Swamp were modest but most occurred where the high bank transitions to a lower bank.

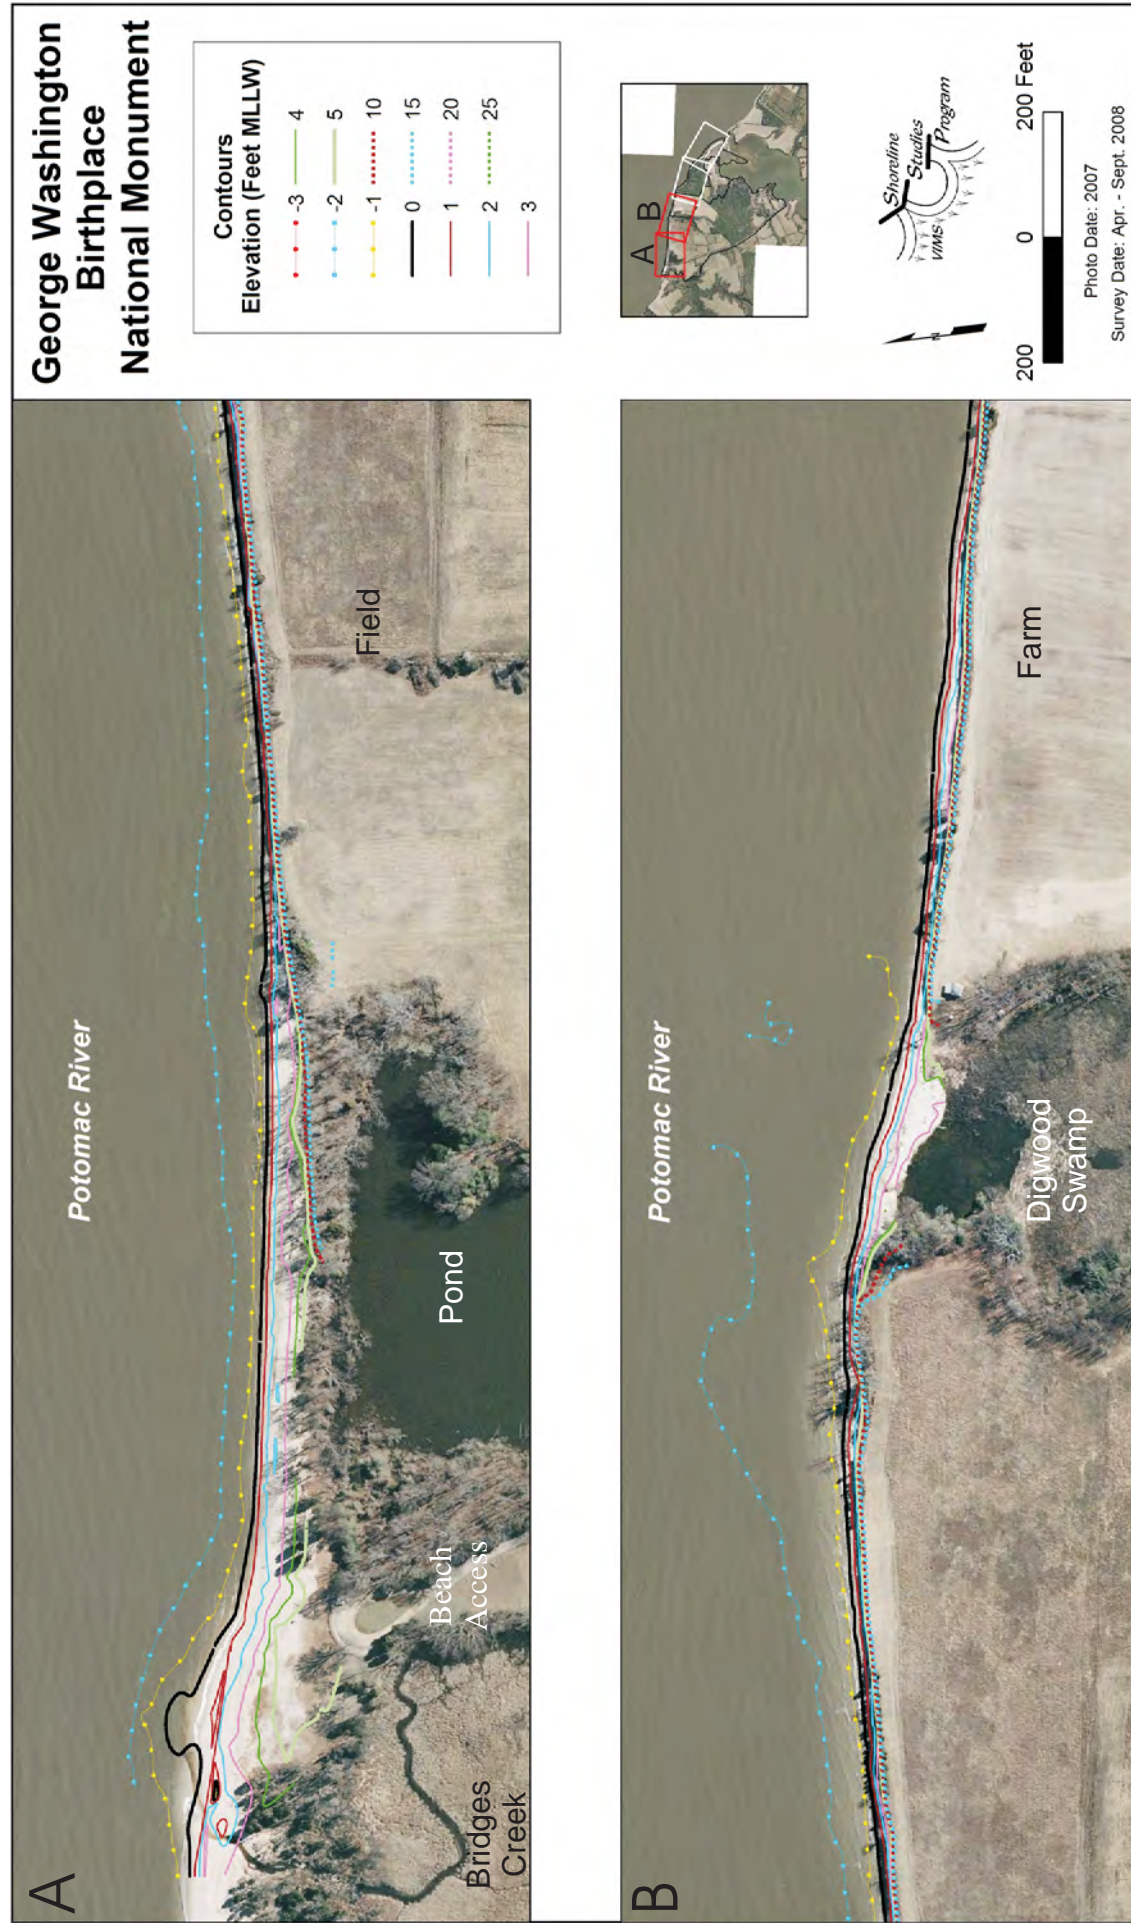
Figure 20. RTK-GPS elevation contours along GEWA's western Potomac River shoreline.

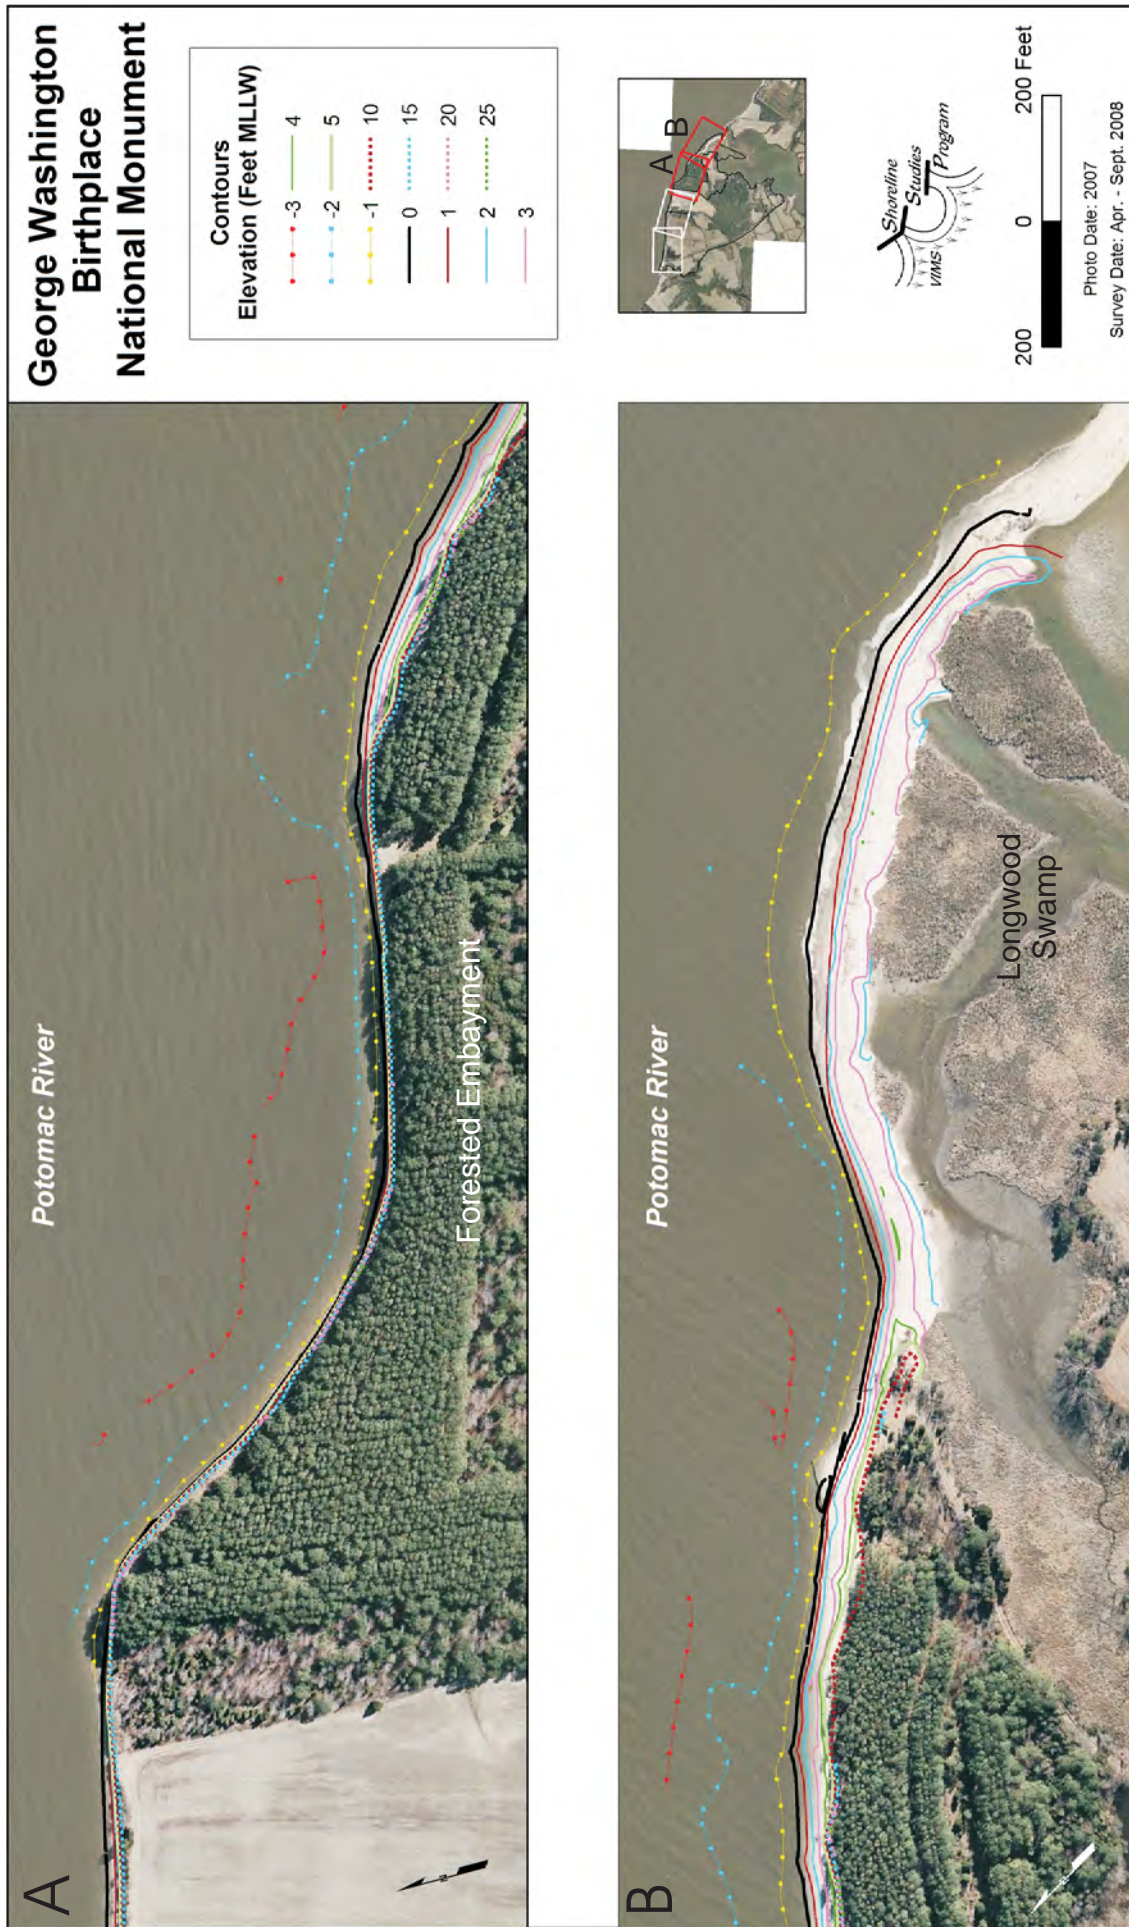
Figure 21. RTK-GPS elevation contours along GEWA's eastern Potomac River shoreline.

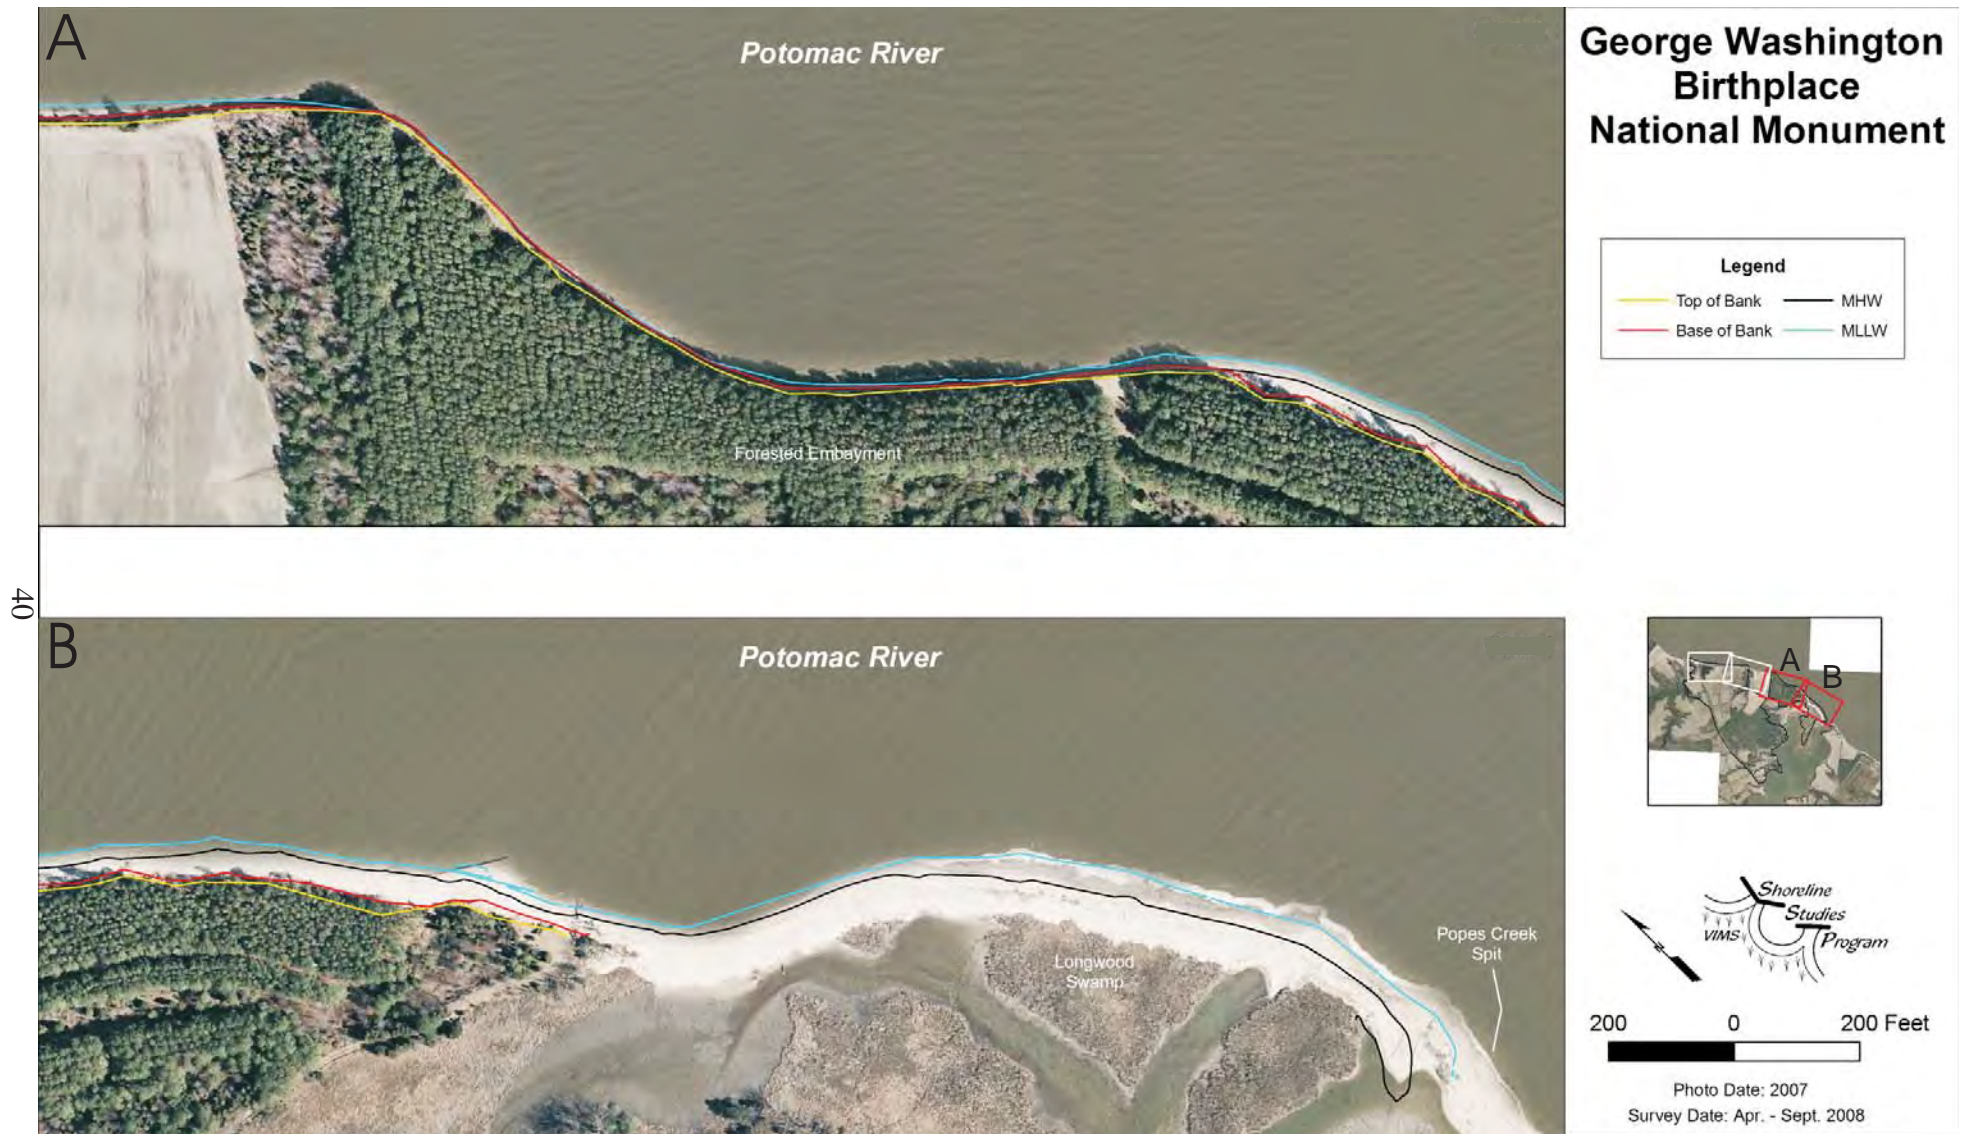
Figure 23. RTK-GPS survey results showing the top of bank, base of bank, mean high water, and mean lower low water along GEWA's eastern Potomac River shoreline.

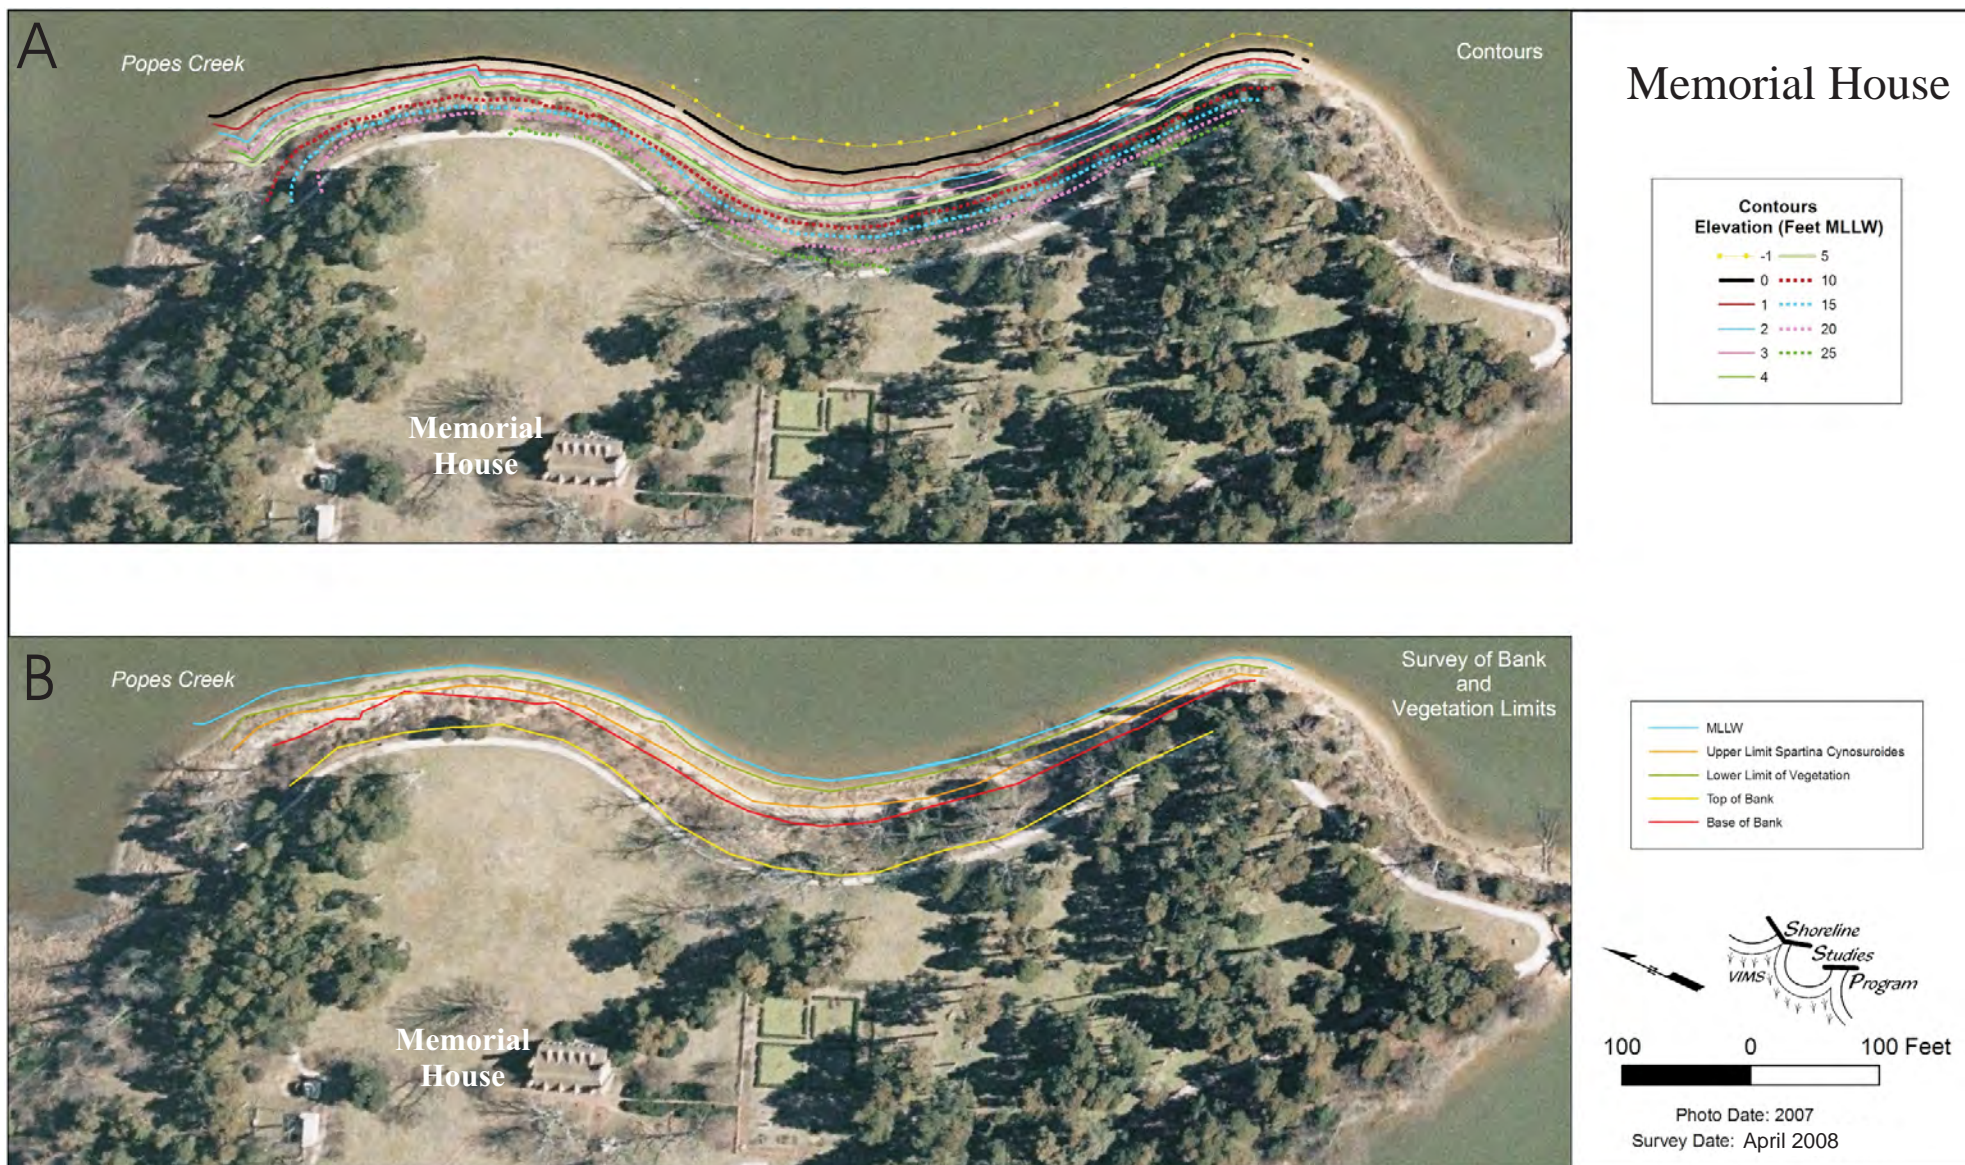
Figure 25. Survey results along GEWA's Popes Creek shoreline at the Memorial House showing A) elevation contours and B) topographic and vegetative features.

Figure 25A presents the surveyed elevations and Figure 25B the locations of the tops and base of the bank and tidal datums along Popes Creek in front of Memorial House. The shore along Popes Creek is not nearly as steep as along the Potomac and has a vegetative marsh fringe (Appendix A, photos 25-28). The elevations immediately inland are higher (maximum 27 ft (8.2 m) MLLW) than along the Potomac.

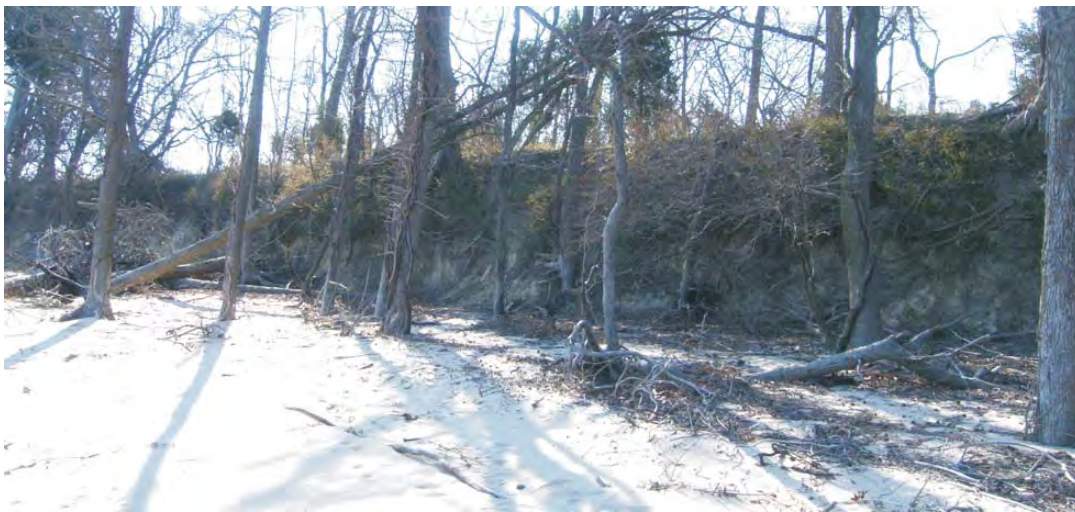
5. Bank erosion in front of the pond.

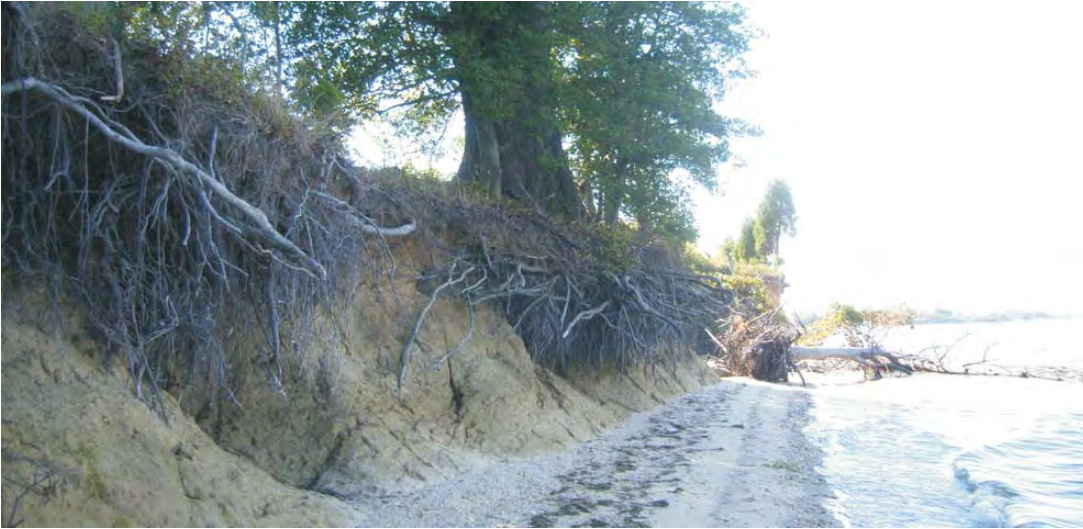
10. Erosional headland west of Digswood Swamp

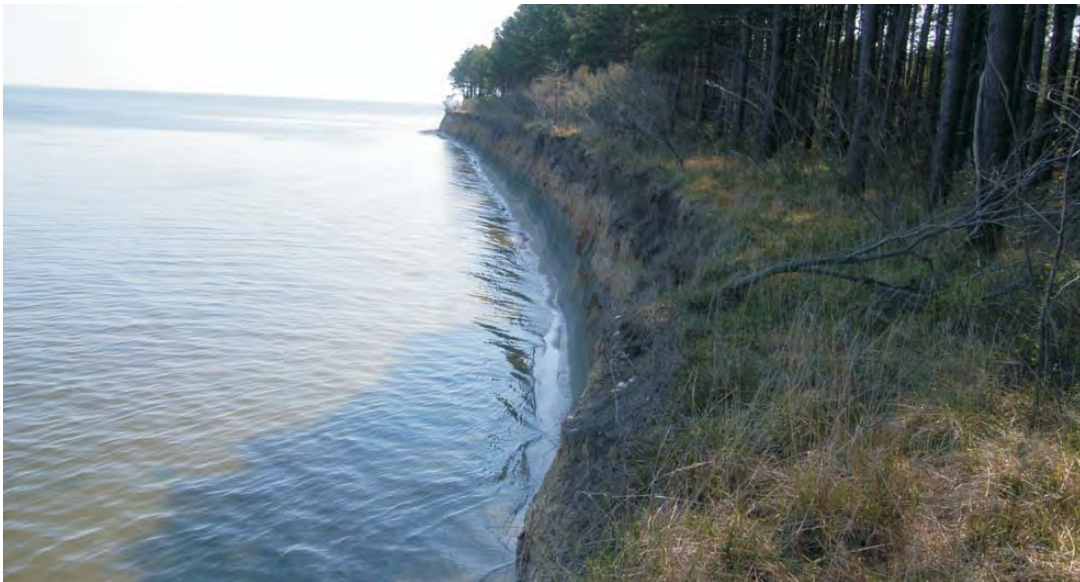
14. Vertical banks with no beach at high water in forested embayment

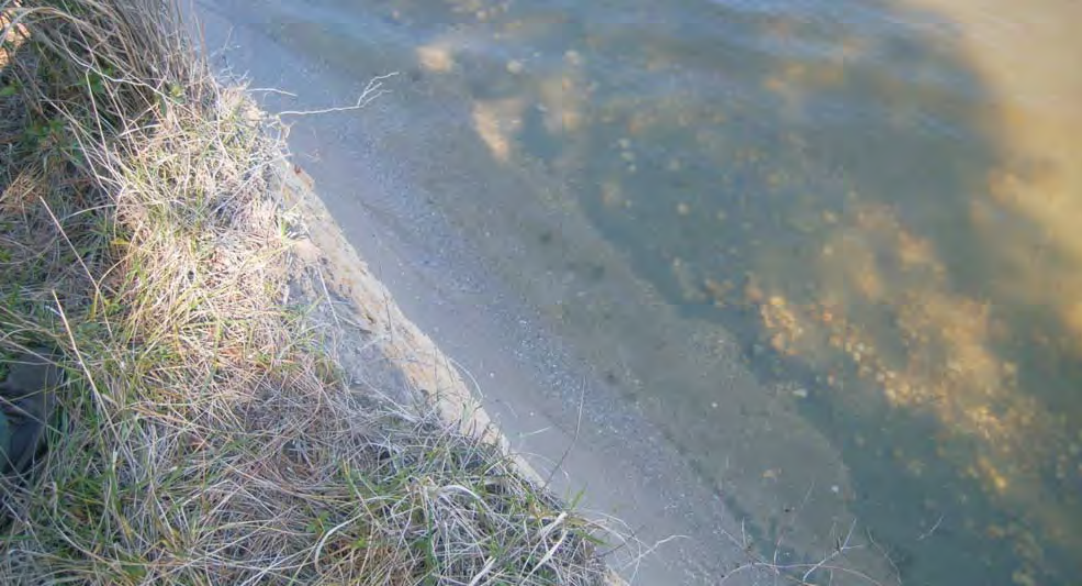
16. Vertical bank face.

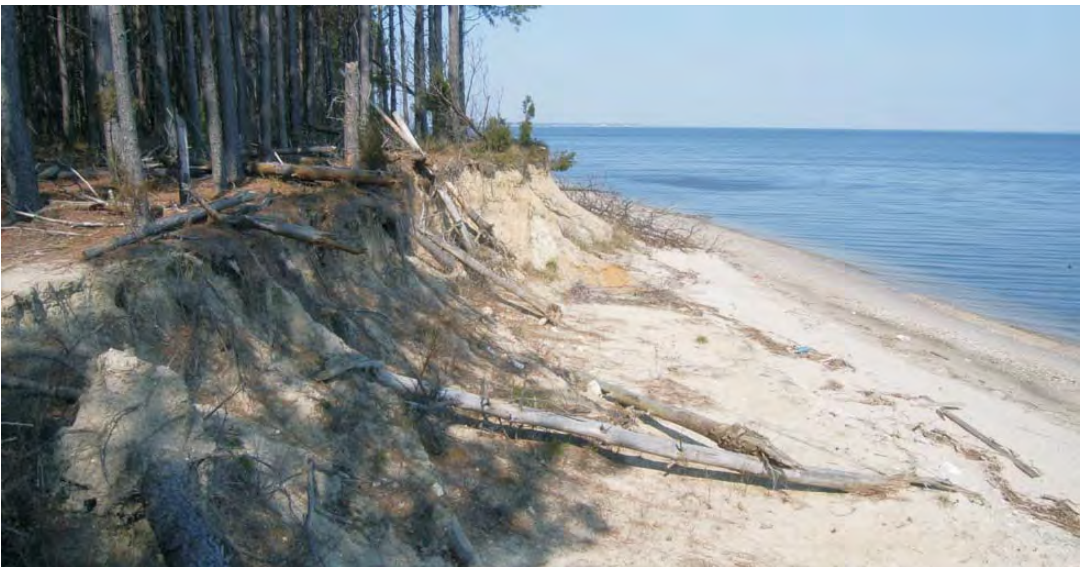
18. Eroding banks along the northeast facing shoreline.

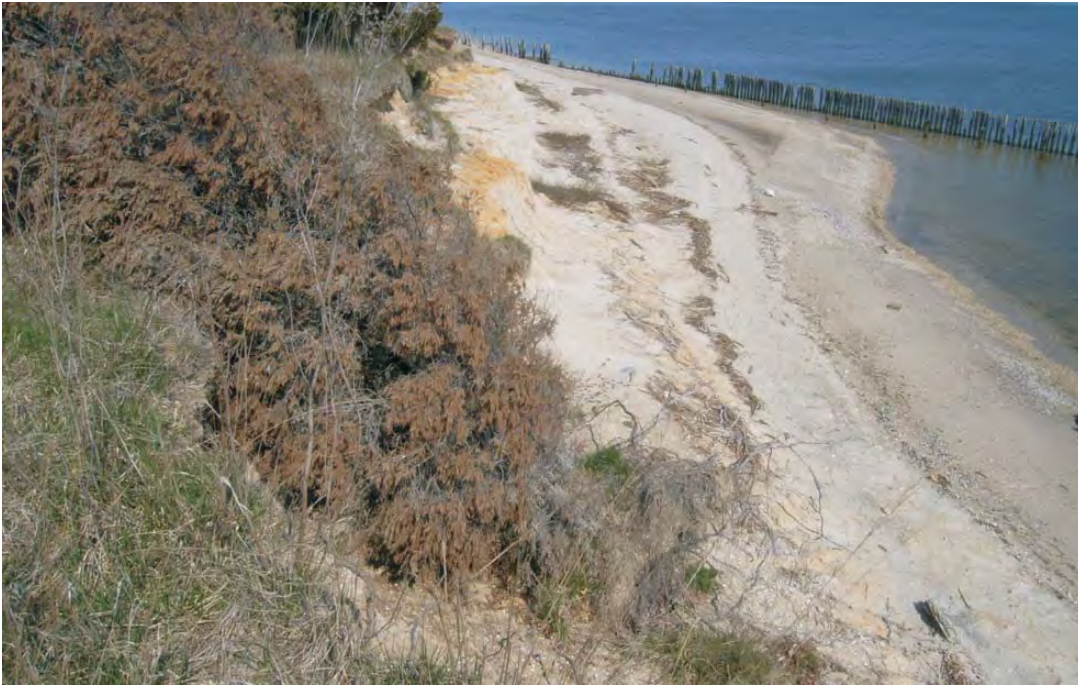
19. Along the northeast facing shoreline north of the sandy spit - Remnants of an old bulkhead are

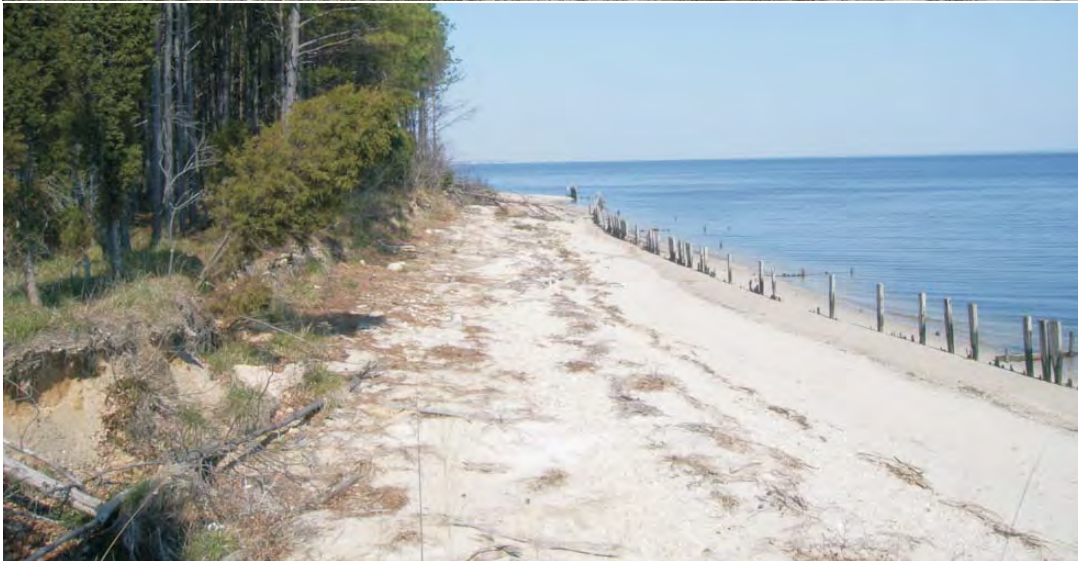
20. Shoreline where the sandy spit that fronts Longwood Swamp attaches to the upland - Remnants of an old bulkhead are evident.
